The Loss of USAF B29A #44-62276 on 17th January 1949 near Strachur, Scotland.

An investigation and compilation of all known material facts surrounding the death of 20 USAAF personnel who were returning to the USA from England after a 3 month detachment as part of support to the Berlin Airlift.

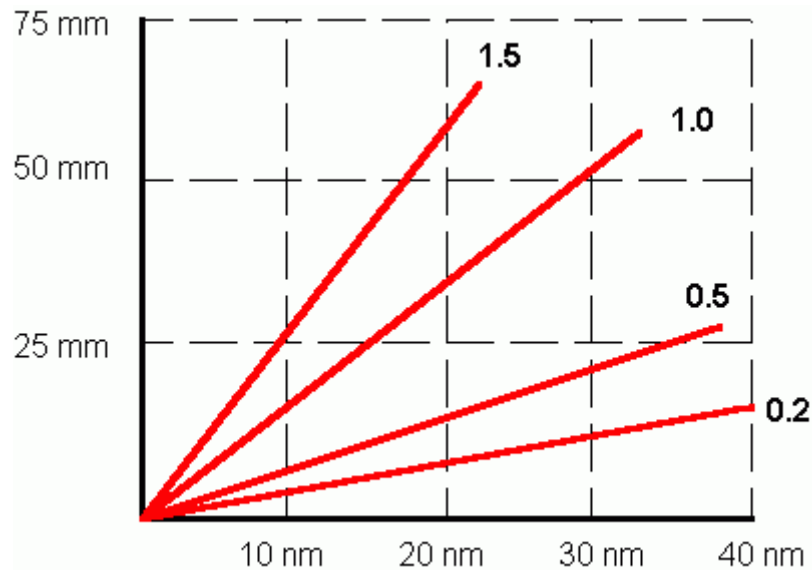
The diagram below shows the ice accretion in mm on a small probe for the air miles flown, in clouds with liquid water content varying from 0.2 g/m³ to 1.5 g/m³.

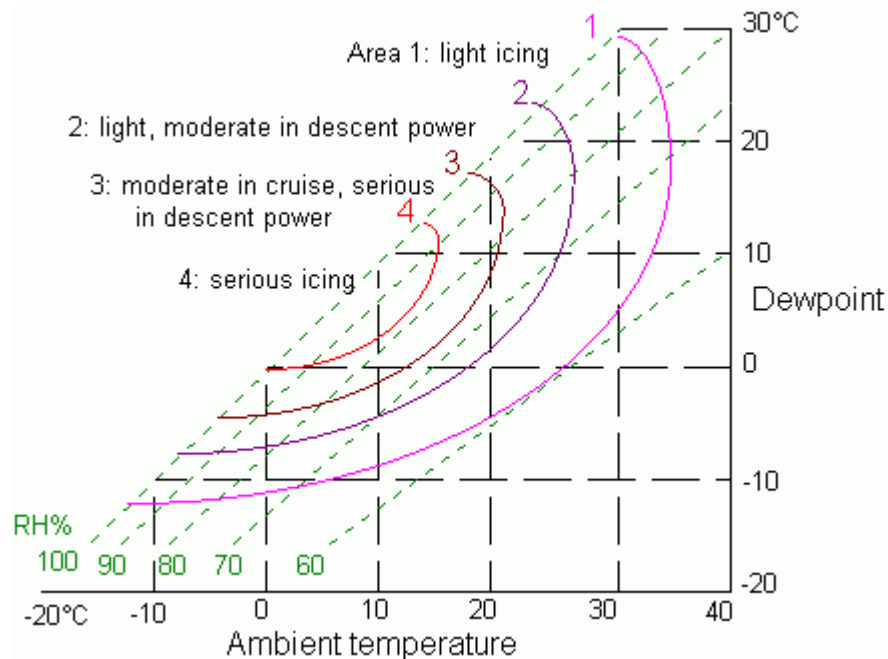
However an OAT range of 0 °C to 25 °C , peaking at around 10 °C to 15 °C, with relative humidity exceeding 60%, are the most significant conditions for moderate to severe clear air icing – particularly at low throttle openings – as shown in the probability diagram below. Note that the region to the left of the 100% relative humidity line would be visible moisture – mist, fog and cloud.
